TECHNICAL REPORT

DA-31-43

SEQUENTIAL STUDY OF DESERT FLOODING IN THE WHITE MOUNTAINS OF CALIFORNIA AND NEVADA

Choster B. Beaty

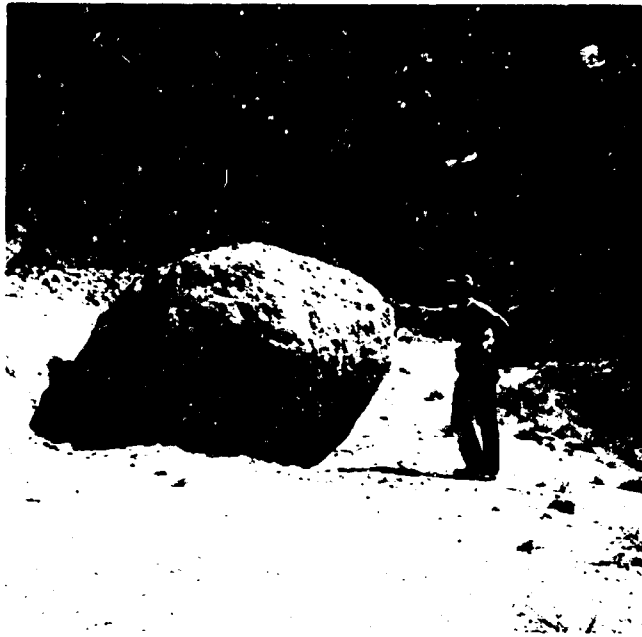
Figure 8. Boulder moved from site in lower canyon (see Figure 7A) to alluvial fan by 1958 debris flow in Sparkplug Canyon.

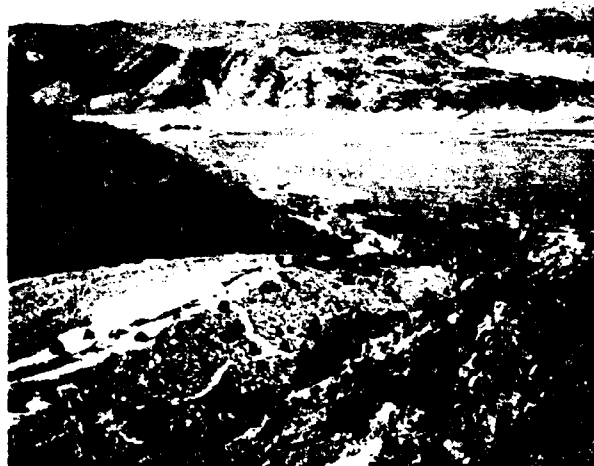
Figure 11. Views upstream (A) and downstream (B) in lower canyon of Montgomery Creek, taken in 1966 from location on north canyon wall. Widening of lower canyon is evident.

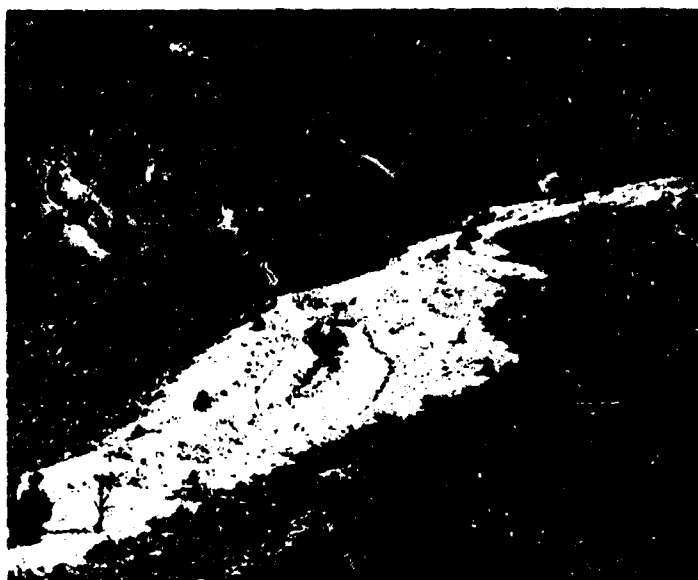
Figure 17. Area of secondary debris spreading just above mouth of Montgomery Canyon. Linear accumulations of large boulders can be seen on both sides of the active channel.

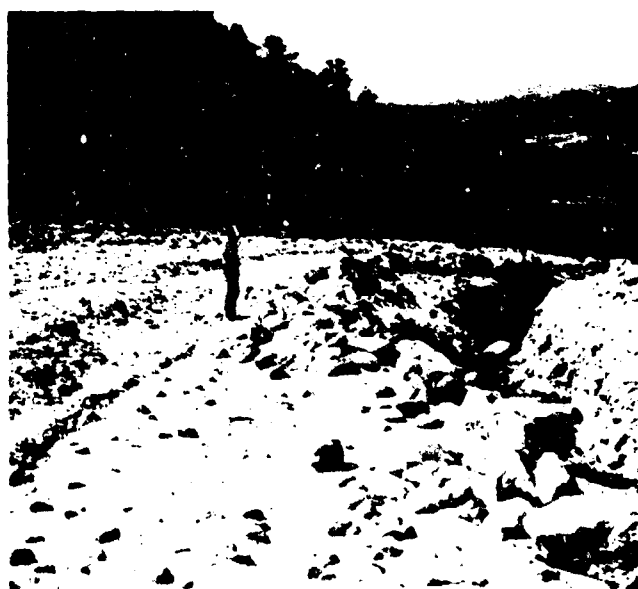
Figure 18. Boulder ridges in lower Montgomery Creek. From the edge of the incised channel to the left margin of the flow at least three distinct ridges can be seen.

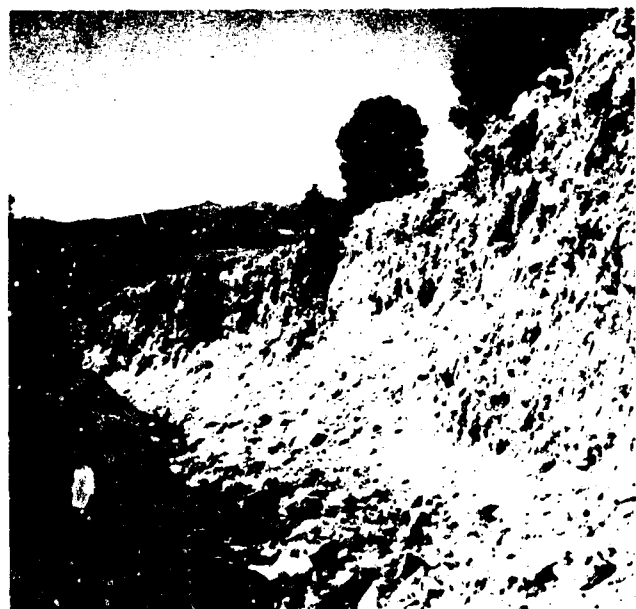
Figure 19. Views of the greatly enlarged active channel of Montgomery Creek from (A) the south rim of the channel and (B) its floor. The pinyon pine trees on the north side of the channel in (B) are about 15 feet high.

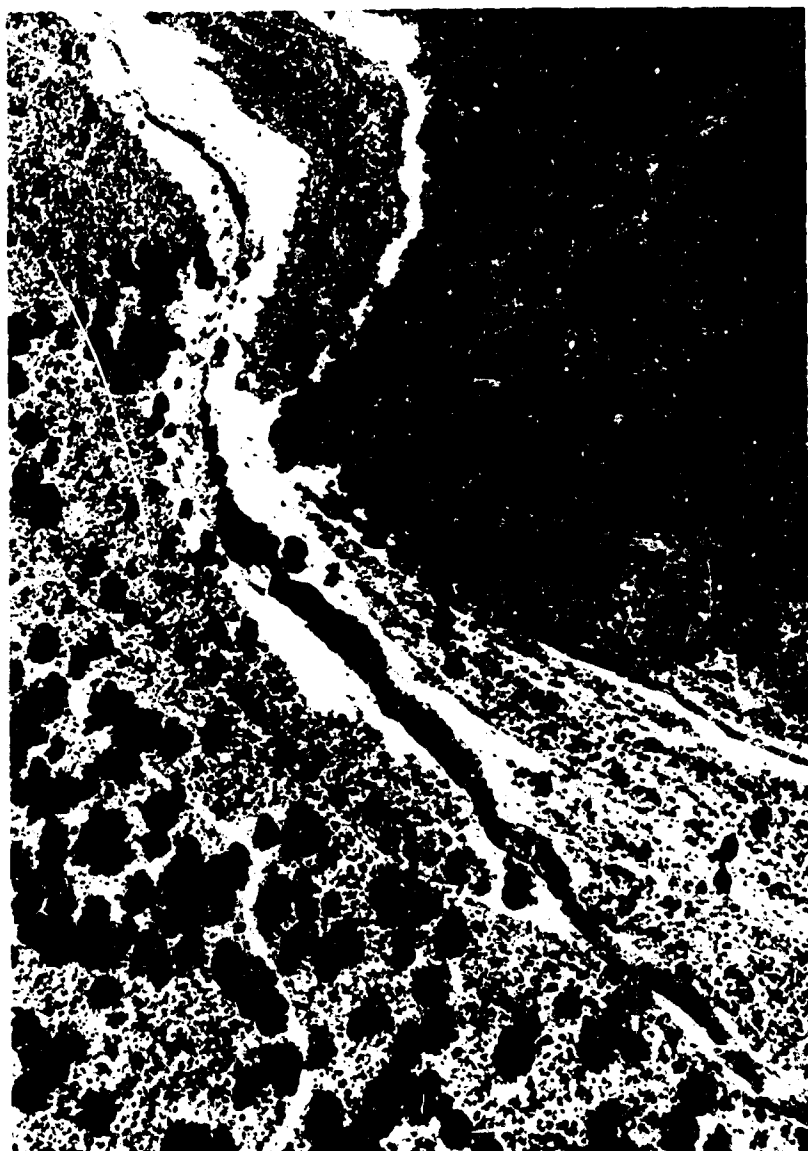
Figure 20. Low-altitude aerial view of the active channel of Montgomery Creek at the canyon mouth-fan apex juncture; debris spilled out of active channel at the point of its closest approach to the south canyon wall (arrow), there to join the subsidiary lobe coming downcanyon from the point of diversion about 1/2 mile above the mouth (see Figure 16).

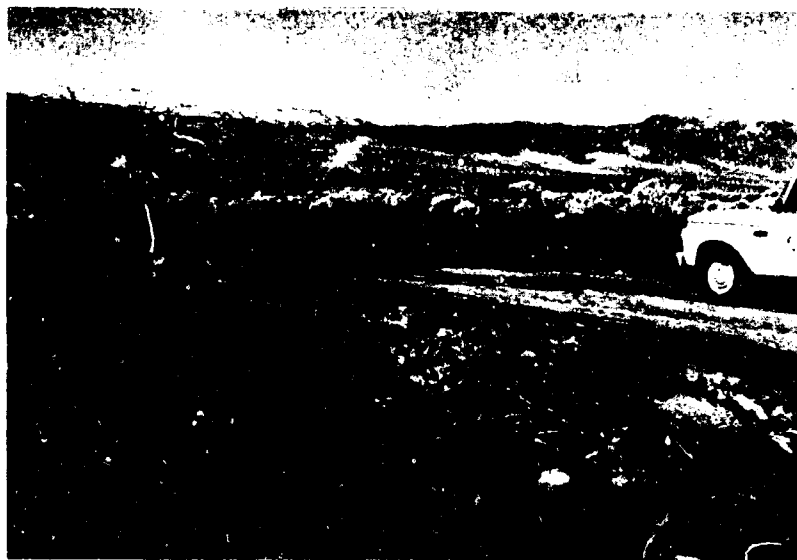
Figure 25. Flood damage to secondary road in Upper Owens Valley, caused by the heavy rains of December 1966.

culvert and temporary flooding and closing of U.S. Highway 6. At another locality a short segment of secondary road was completely cut away by the same runoff (Figure 25). For the first time many decades,

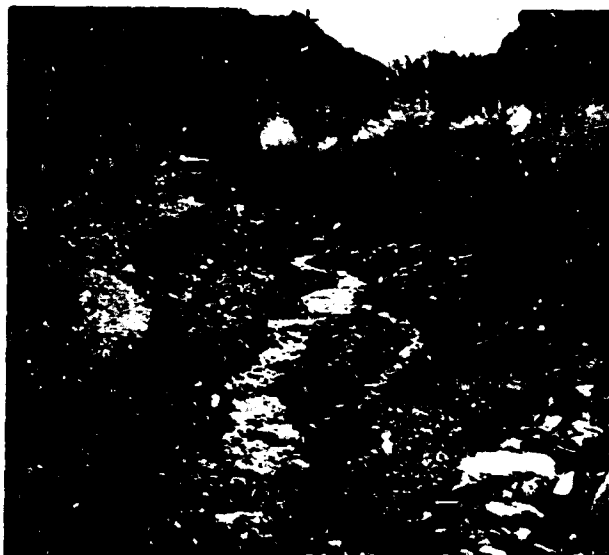
Figure 27. Section of lower Silver Canyon road almost completely washed away by runoff of December 1966.

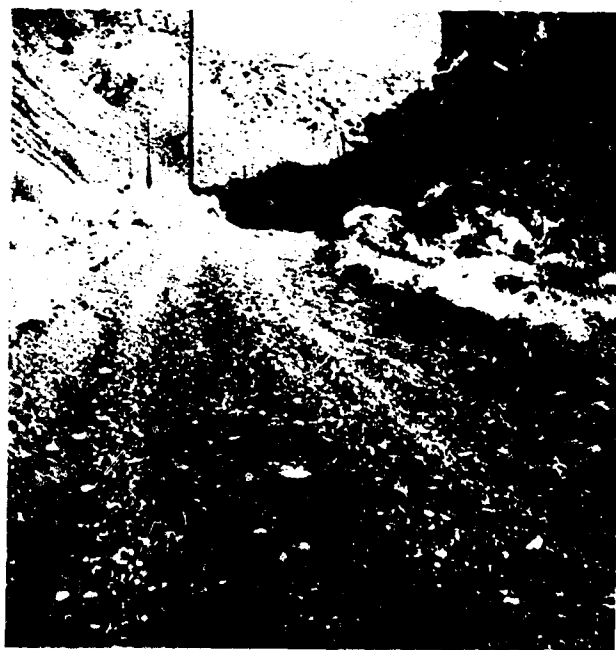
Figure 28. Silver Canyon road above zone of major flood runoff, December 1966. Some cutting is evident, but road is passable.

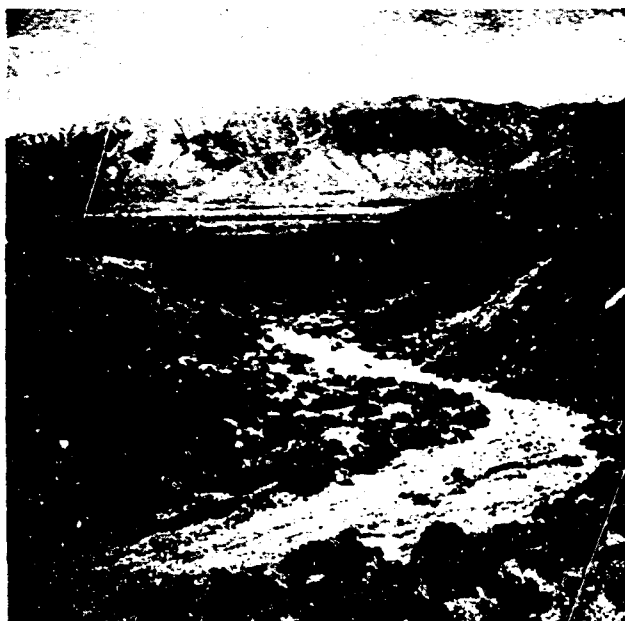
Figure 30. Part of lower Poleta Canyon as it looked in 1956 (A), and as it appeared after the heavy rains of December 1966 (B).

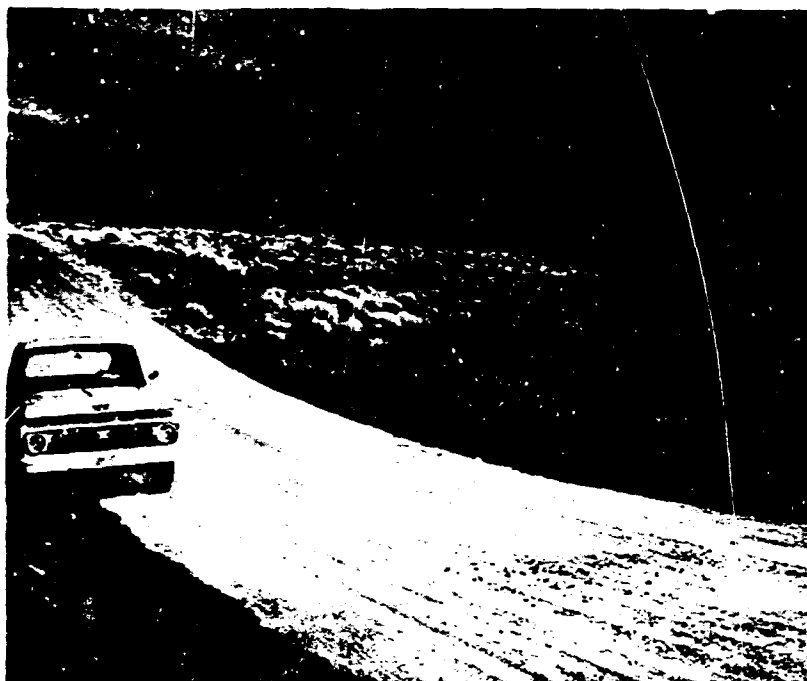
Figure 31. Flooded "dip" on Westgard Pass road, showing depth of debris deposited by runoff of December 1966.

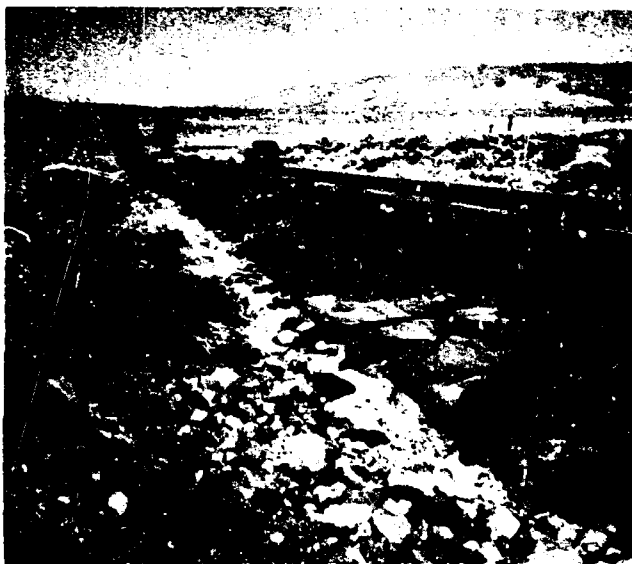
Figure 34. Damage to U.S. Highway 395 between Olancha and Lone Pine. Snow-covered crest of Inyo Range on skyline.

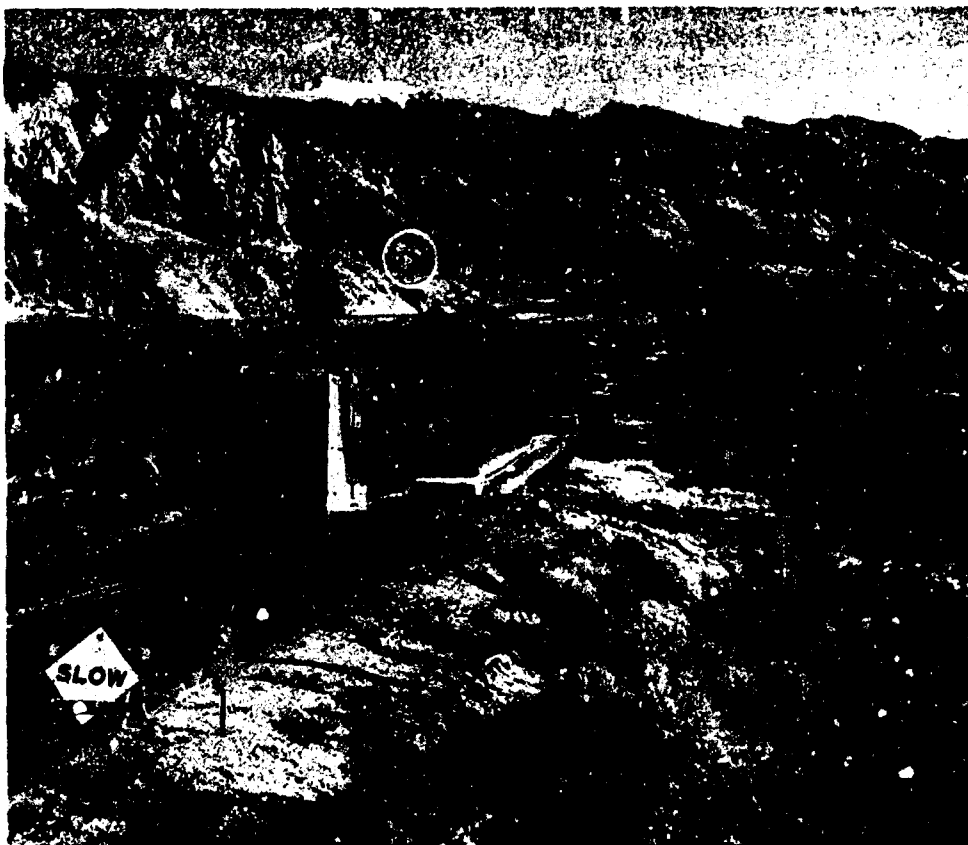
Figure 38. Owens River out of its banks and over California State Highway 135 about 3 miles southeast of Lone Pine, 8 December 1966.

300 feet (Figure 38). Traffic was slowed at this point but not halted.

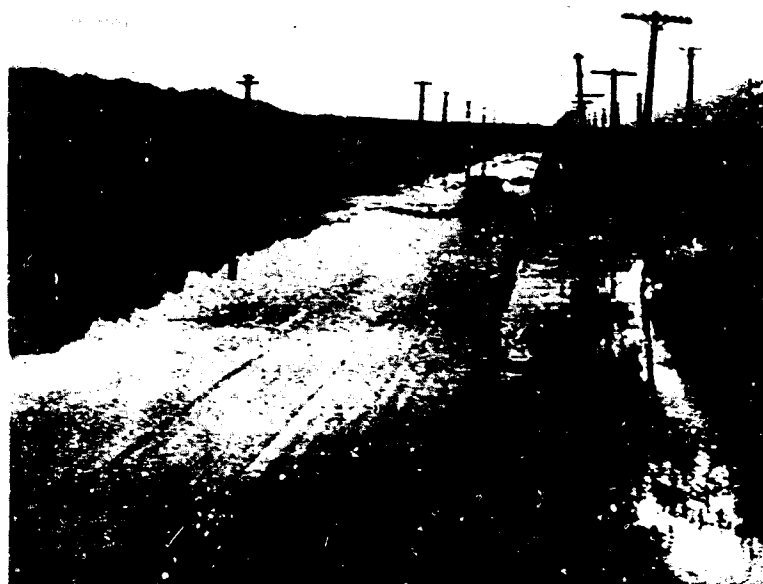
Figure 47. Runoff from Lone Tree Creek across U.S. Highway 6 in Upper Owens Valley, early morning of 13 July 1967. Minor flooding was produced by heavy rains on evening of 12 July 1967.

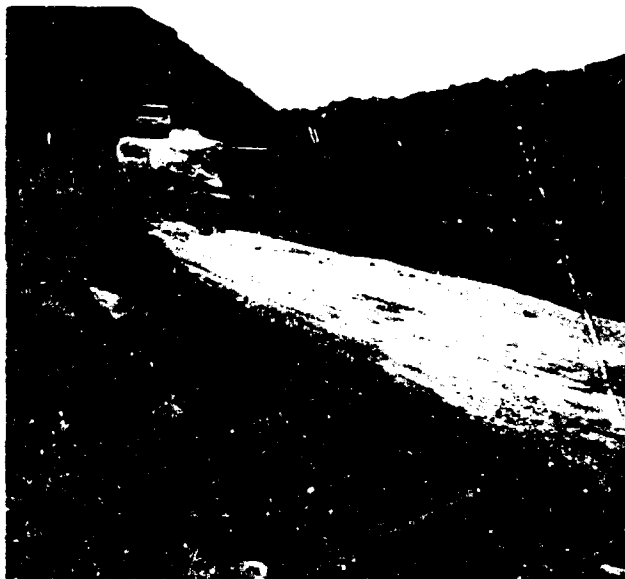
Figure 49. Cleanup work on Westgard Pass road, morning of 14 July 1967.

still being removed (Figure 49).

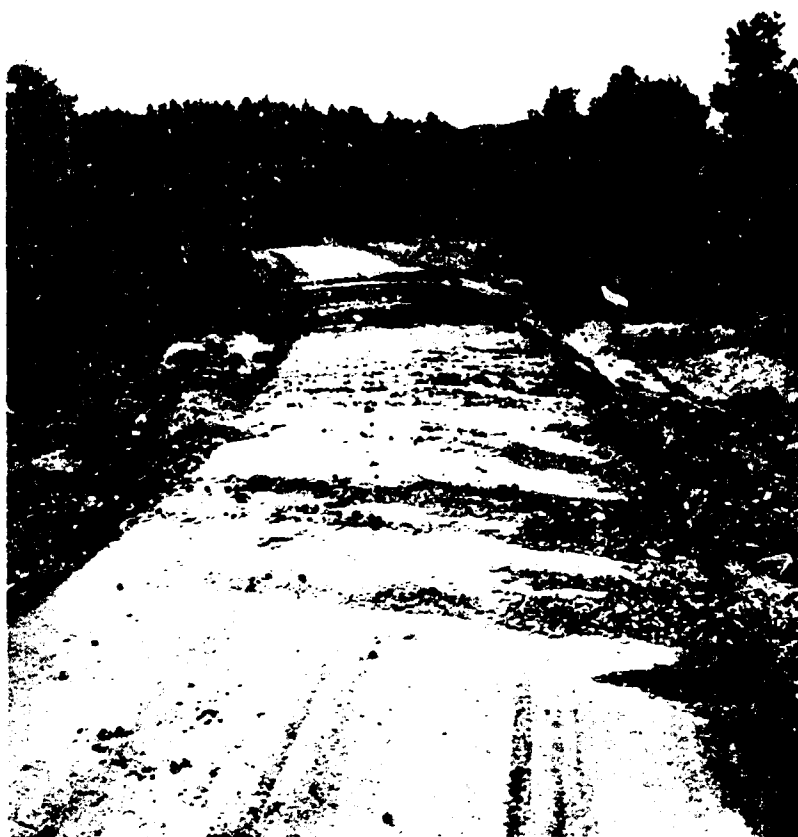
Figure 50. Debris and pine cones on White Mountain crest road, morning of 14 July 1967.
